Markus von Euw Home Inspection
20885 Redwood Road #334
Castro Valley CA 94546
510-427-1605
bayhomeinspection@gmail.com

Confidential Inspection Report

1891 Strobridge Ave.
Hayward, CA 94546

Inspection # 10162010.
Inspection Date: 10/16/2010.
Inspector: Markus Von Euw.
Client: Ted, A'Beckett.
Property Address: 1891 Strobidge Ave., Hayward, CA 94546.
Weather Conditions: Mild.

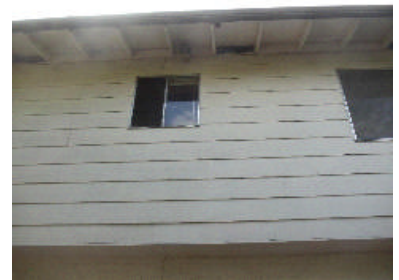
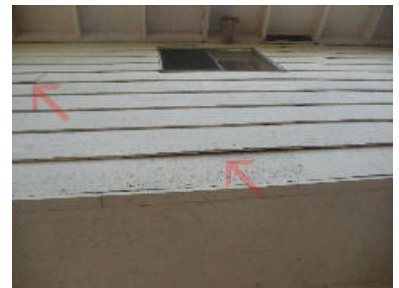
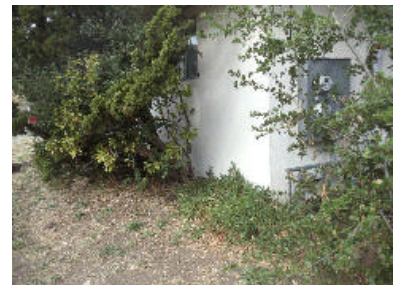
some of the wood sidings are lifting.

Suggest trimming all trees and vegetation away from home. Vegetation in contact with or encroaching with building materials may trap moisture causing damage/deterioration, harbor insects or rodents and allow the growth of mold/mildew.

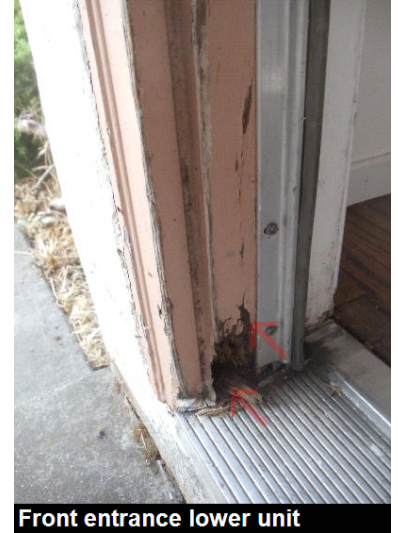
Wood. Deterioration noted. We suggest further evaluation by a Licensed Branch III Structural Pest Control Operator for identification and any remediation deemed necessary by the pest control company.

By the front Entry of the lower unit. - deterioration noted.

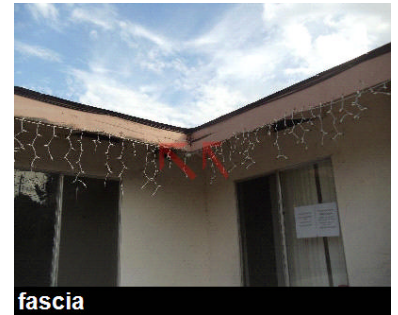
And next to front entrance fascia - deterioration noted.

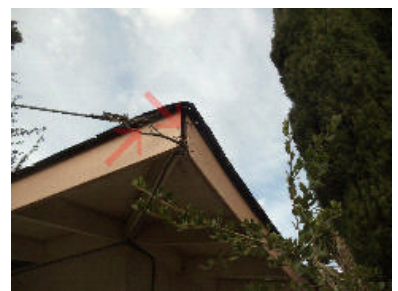
fascia is pulling away.

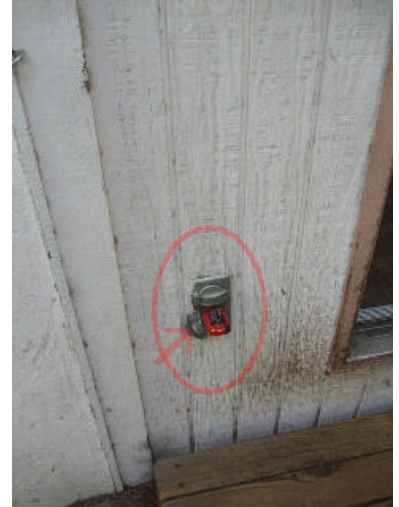
Weather tight plug cover damaged.

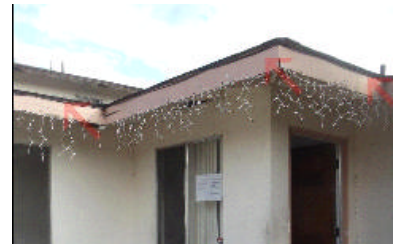
Suggest adding gutters/downspouts as a future upgrade.

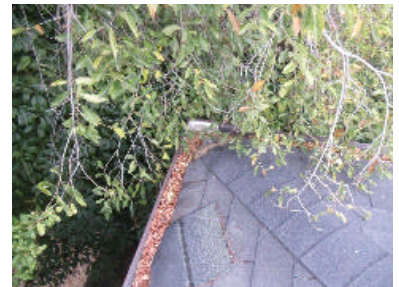
Debris noted in gutter should be removed to prevent clogging.

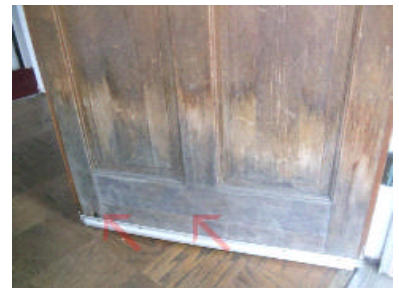
Entry door lower unit. weathered. and damage noted.

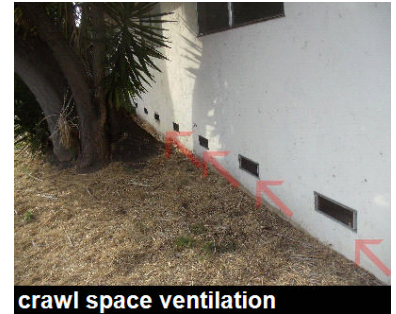
crawl space ventilation

Some of the exterior ventilation screens were noted to be damaged . We recommend they be replaced to keep animals out of the crawl space.

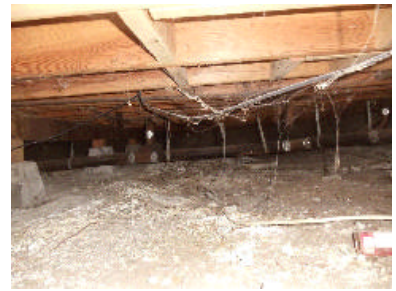
Vapor Barrier: There was no vapor barrier in place in the crawl space. A vapor barrier is considered a beneficial feature. This will help create a dry air space between the dirt and the framing and limit the amount of moisture that is able to rise into the framing, and reduce the possibility of future moisture damage. We recommend consideration be given to a vapor barrier being installed as a future upgrade.

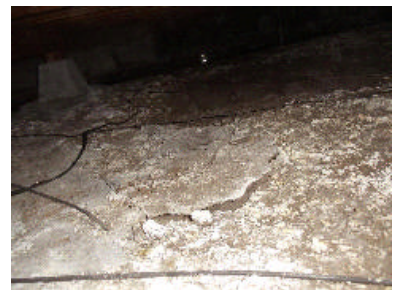
White efflorescence powder deposits noted are mineral salts left when moisture evaporates and is indicative of moist conditions in the area.

Evidence of prior water entry exist. We recommend drainage control improvements to help keep the foundation dry. A wet crawl space can be a health hazard to some people. If concerned, we recommend further investigation to determine if there exists an ongoing climate for incubation of microbial contamination and that steps be taken to eliminate this climate."

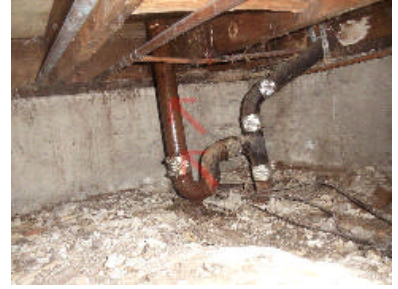
Evidence of leaking plumbing, suggest review/correction by a qualified licensed plumber before the close of escrow.

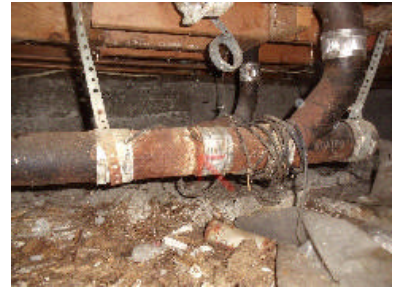
Rust and or corrosion noted.

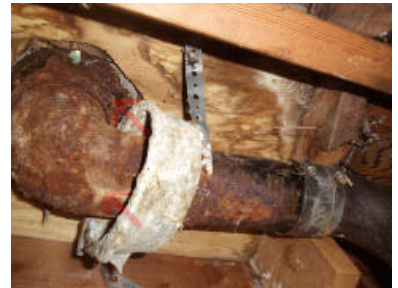
Rust and or corrosion noted at the drain for toilet at lower rear bathroom.

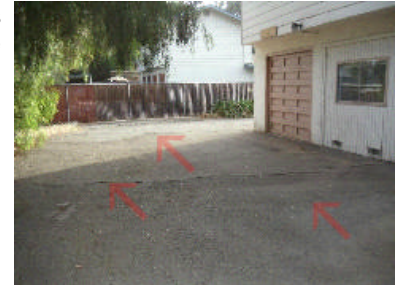
Concrete, Stress/shrinkage/settlement cracks noted. Displaced and expansive cracking. Possible trip hazard.

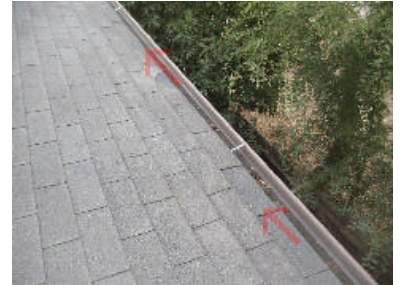
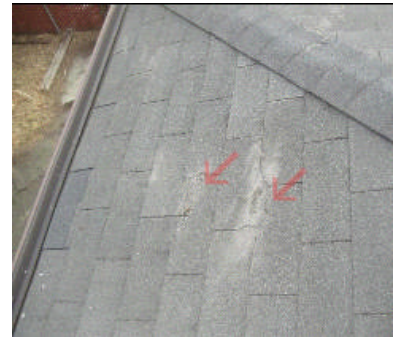
Roof access: The inspector walked on the roof and viewed the accessible roofing components.
302 *Flashing:* No drip rail flashing noted at eaves . May not have been required at time of construction.
303 *Drains/Waste vents:* S.
304 *Comments:* Roofing materials are poorly installed.

Suggest complete review/correction including cost estimate (bids) by a qualified licensed roofing contractor before the close of escrow.

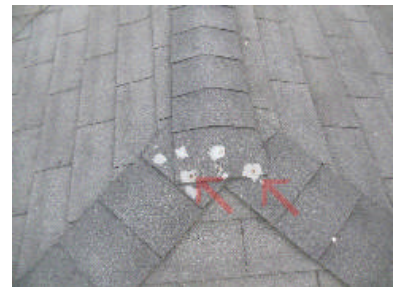
Nails/Fasteners are protruding from the roof surface. Maintenance is needed.

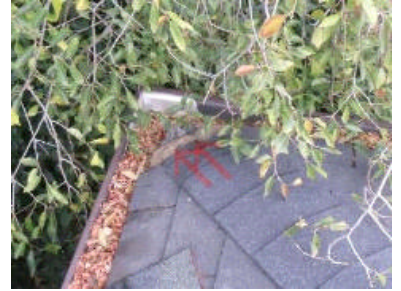
damages at the corners of the roof, exposed sheathing noted.

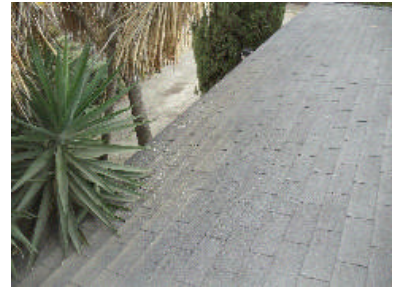
Debris on roof should be removed to prevent water from damming and to extend roofing life. The debris reduces the flow of roof water runoff and increases the potential for leakage. We recommend correcting the condition(s) noted.

Suggest trimming all trees and vegetation away from roof.

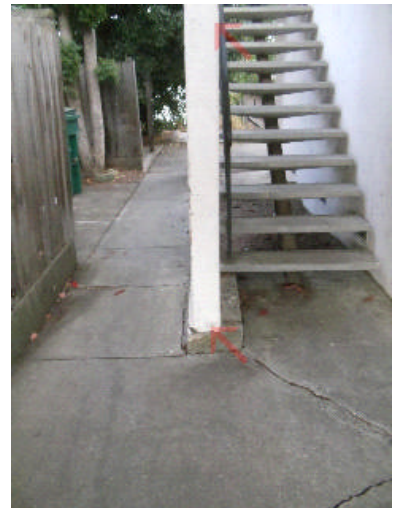
foundation appears to have setteled.
Stress/shrinkage/settlement crack noted.

Suggest further review by appropriate person if concerned.

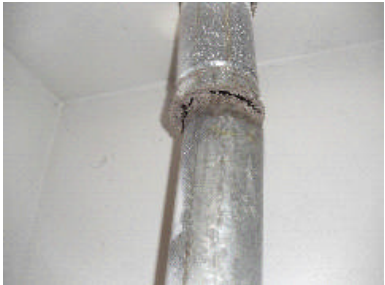
Exhaust vent is loose. vent pipes will allow products of combustion to escape. This is a safety hazard needing immediate attention.

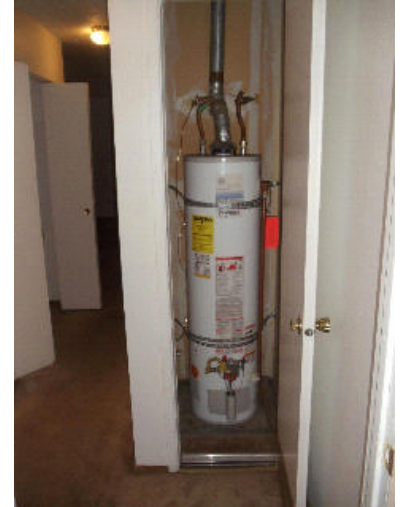
Brand Name(s) General Electric.
Aprox. Age(s) 2003.
Location: Utility room.
Shutoff valve: Cold water shutoff valve intact.
TPR Valve: Temperature, pressure relief valve noted as required.
Drain line: Drain line installed.
Combustion Air: Suggest review by appropriate person.
Earthquake safety: Earthquake safety straps installed.
Comments: The unit was inoperable at time of inspection. liquid petroleum gas water heater installed, needs to be corrected. gas water heater required.

The water heater was not functioning. The proper configuration of "HOT on the LEFT" and "COLD on the RIGHT" at each of the faucets could not be confirmed. We recommend a full evaluation and/or corrections by a specialist in the appropriate trade.

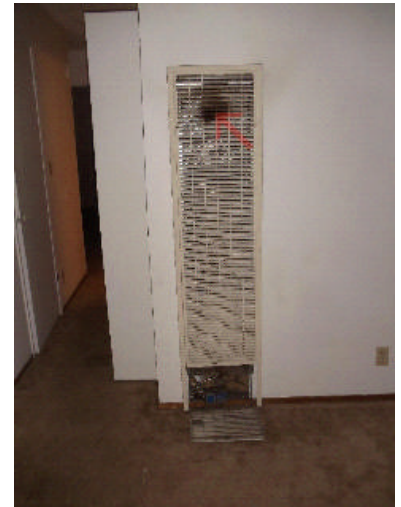
Approx. Age(s) Unknown, ID tag missing or illegible.
 Filter: Located in unit.
 Combustion Air: Combustion air provides oxygen for fuel-burning appliances. Adequate ventilation around all fuel-burning appliances is vital for their safe operation.
 Shut off/disconnect: There is a gas shutoff valve and electrical receptacle noted near this appliance.
 Conditions: There was good air flow to all the rooms.
 810b Venting #1: S.
 810c Heating #2: Inoperable. Gas, wall unit.

Location: Upper unit, Living Room.
 Approx. Age(s) older.
 Shut off/disconnect: There is a gas shutoff valve noted near this appliance.
 Conditions: Advise complete review/correction including cost estimate.

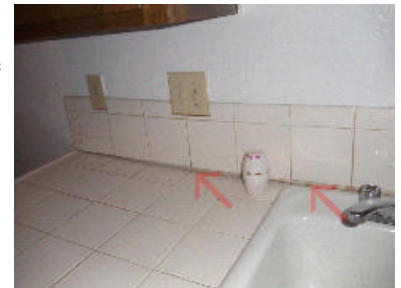
900 Location:	lower Kitchen.
901 Floor:	S;
902 Walls:	S.
903 Ceiling:	S.
907 Cabinets:	Finish is worn.
908 Counter tops:	Tile. cracked material noted. We suggest caulking or regrouting as needed, open joints may allow moisture intrusion. Maintenance of the joints is strongly advised.

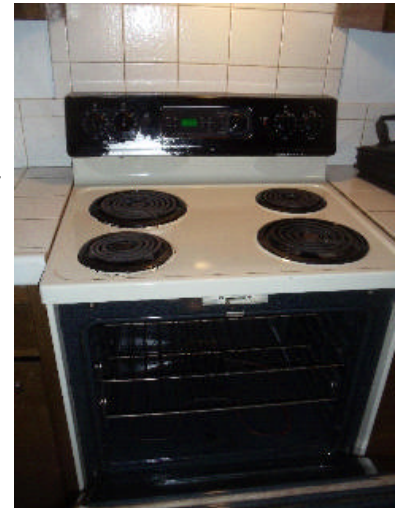
One of the cooktop/ range burners was inoperative. We recommend correcting the condition(s) noted.

The range/oven lacked an anti-tip device at the rear as required. This condition is a topple and impact hazard. We recommend correcting the condition(s) noted for safety reasons.

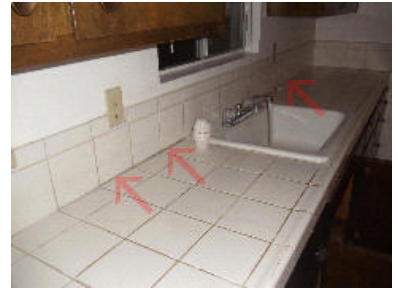
938 Counter tops: Water damage noted, under sink.
 Tile. Cracked material noted

We suggest caulking or regrouting as needed, open joints may allow moisture intrusion. Maintenance of the joints is strongly advised.

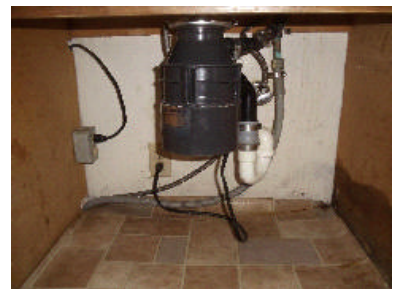
943 Disposal(s): The disposal was jammed/ frozen. We recommend correcting the condition(s) noted.

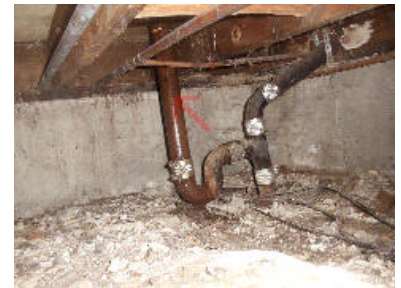
1018 Traps/Drains/Supply: Leaking noted from crawl space by bath tub drainage.

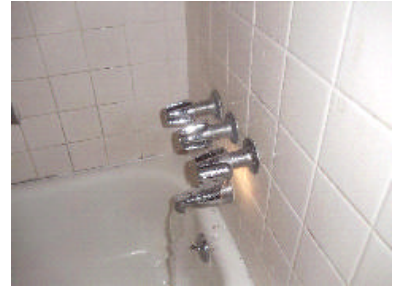
- 1032 *Electrical:* No ground fault circuit interrupters installed. - may not have been required at time of construction. Upgrade recommended.
- 1033 *Exhaust Fan:* S.
- 1035 *Tub & Surround:* We suggest caulking or regrouting as needed, open joints may allow moisture intrusion. Maintenance of the joints is strongly advised.
- 1037 *Tub Faucet:* Leaking noted, at controls.

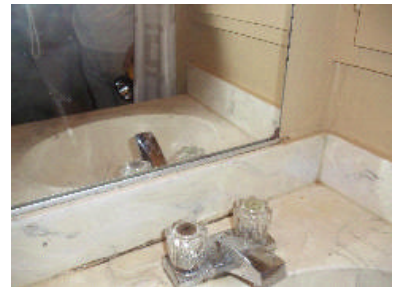
- 1041 *Sink:* We suggest caulking or regrouting as needed.

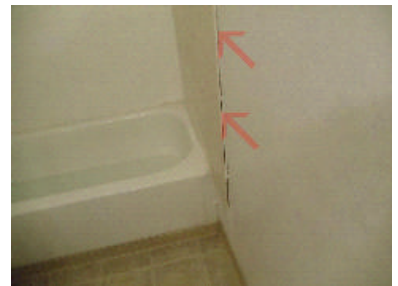
surface from tub wall is lifting at some places.

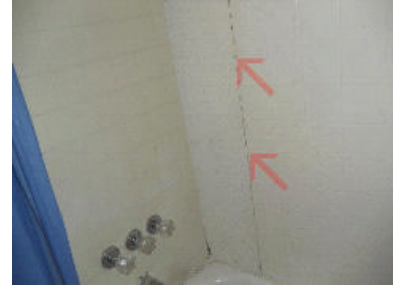
concern that moisture may enter behind the tub wall.
Seam lifting.

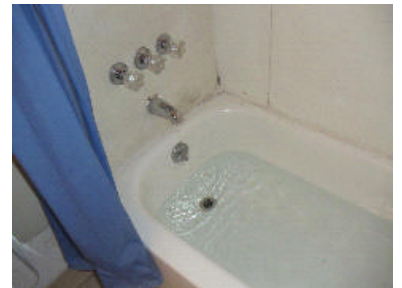
Slow drain noted at tub.

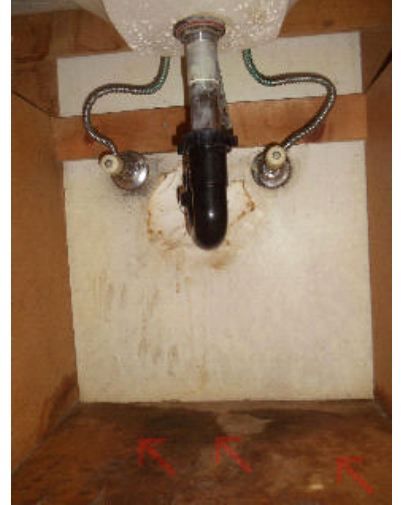
Water damage noted under sink.

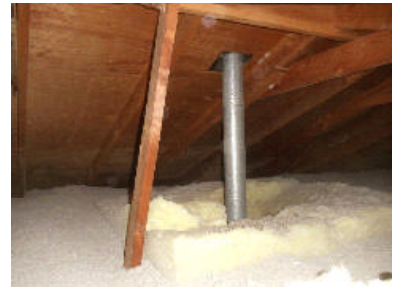
1754 Evidence of leaking: Yes, appears to be old water stains.
 1755 Insulation: lower section Where visible thickness of insulation material is approximately, 2-4". Unable to view area beneath insulation. Old insulation.
 upper section. 10-12". Unable to view area beneath insulation. New insulation.

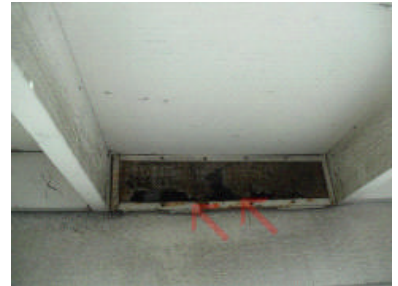
1756 Ventilation: Appears to be adequate, vents located at eaves, Torn or missing screens noted should be repaired.

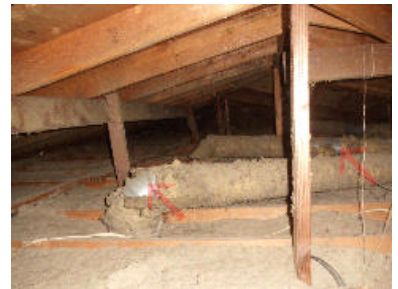
1758 Ducting: Some Insulation or vapor barrier covering on ducting is damaged and should be taped or repairs made to maintain energy efficiency.

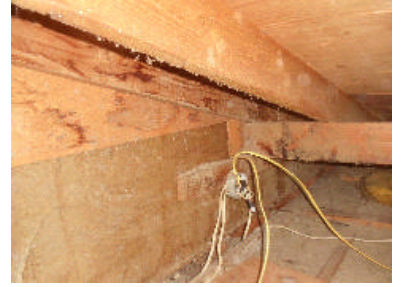
Open splices/open junction boxes were noted. at the lower section. This is a safety concern. Whenever an electric wire is cut and reconnected, the "splice" should be encased in a covered junction box to prevent shocks and separation of the splice. We suggest review/correction by a licensed electrician to ensure safety, prior to close of escrow.
