Markus von Euw Home Inspection
20885 Redwood Road #334
Castro Valley CA 94546
510-427-1605
bayhomeinspection@gmail.com

Confidential Inspection Report

1891 Strobridge Ave.
Hayward, CA 94546

Inspection # 10162010.
Inspection Date: 10/16/2010.
Inspector: Markus Von Euw.
Client: Ted, A'Beckett.
Property Address: 1891 Strobidge Ave., Hayward, CA 94546.
Weather Conditions: Mild.

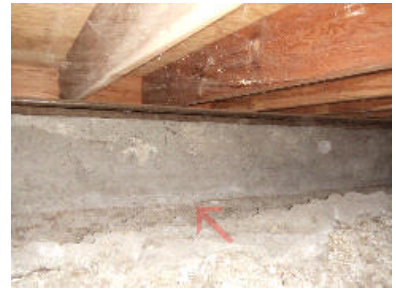
Conditions: foundation appears in good condition.

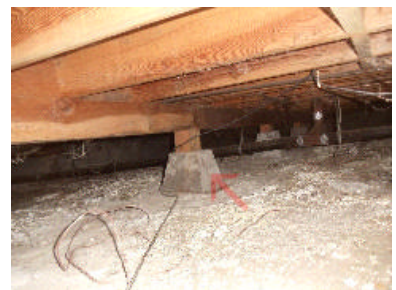
Posts and piers appear to be in good conditions.

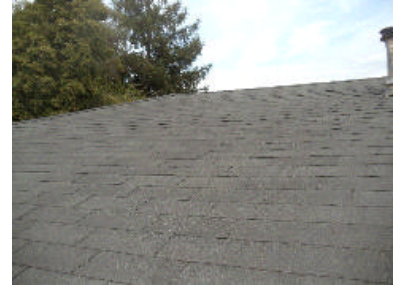
301 *Type/material:* Sloped/ Multiple layer, Composition shingle.

Roof access: The inspector walked on the roof and viewed the accessible roofing components.
302 *Flashing:* No drip rail flashing noted at eaves . May not have been required at time of construction.
303 *Drains/Waste vents:* S.
304 *Comments:* Roofing materials are poorly installed.

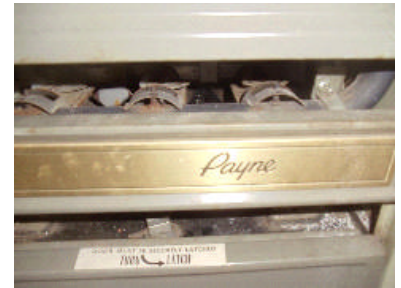
810a Heating #1: S; Gas, central air unit.
 Location: lower unit, Located in utility closet.
 Brand Names: Payne.

Approx. Age(s) Unknown, ID tag missing or illegible.
 Filter: Located in unit.
 Combustion Air: Combustion air provides oxygen for fuel-burning appliances. Adequate ventilation around all fuel-burning appliances is vital for their safe operation.
 Shut off/disconnect: There is a gas shutoff valve and electrical receptacle noted near this appliance.
 Conditions: There was good air flow to all the rooms.
 810b Venting #1: S.
 810c Heating #2: Inoperable. Gas, wall unit.

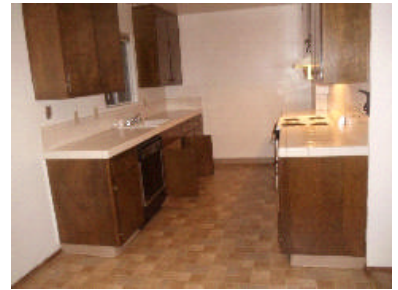
930 Location: upper unit.

931 Floor: S;
 932 Walls: S.
 933 Ceiling: S.
 937 Cabinets: Finish is worn.

938 Counter tops: Water damage noted, under sink.
 Tile. Cracked material noted

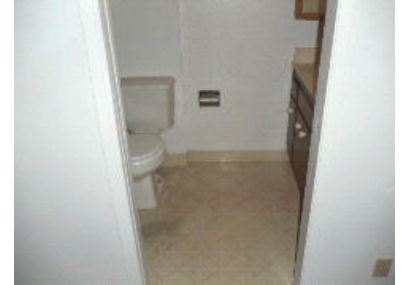
1000 Location: Lower unit.

1007 Electrical: No ground fault circuit interrupters installed. - may not have been required at time of construction. Upgrade recommended.

1010 Tub & Surround: Tile, damaged and missing.

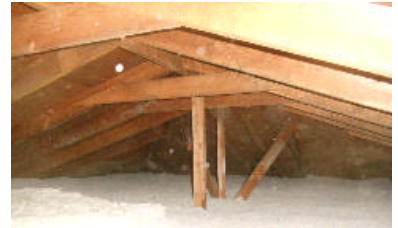
1751 Hatch: Located in lower unit. and upper unit.
 1753a Sheathing: Plywood material.
 1753b Framing: S;

1754 Evidence of leaking: Yes, appears to be old water stains.
 1755 Insulation: lower section Where visible thickness of insulation material is approximately, 2-4". Unable to view area beneath insulation. Old insulation.
 upper section. 10-12". Unable to view area beneath insulation. New insulation.
